Optimization of Francis turbine start up procedure to extend runner lifetime

Litostroj Power is performing a refurbishment of three low head Francis units, where distributor with mechanism is being replaced, other vital parts refurbished and runners reused after runner blades repair.

This article presents measurement of mechanical stress on runner blades trailing edge close to the runner crown of the unit two. Stress was measured with strain gauges using wireless WIFI connections from rotating parts and analysed during unit start-up sequence into mechanical run, unit transients, closing of main inlet valve under discharge and unit steady state operation at various levels of the loads from minimal to maximal power in the operating range. Aim of stress measurement on the runner blades was, to acquire data of average and peak to peak stress on the runner blades, its pulsations with frequency spectrum and to evaluate possibilities to decrease present stress during unit operation [1].

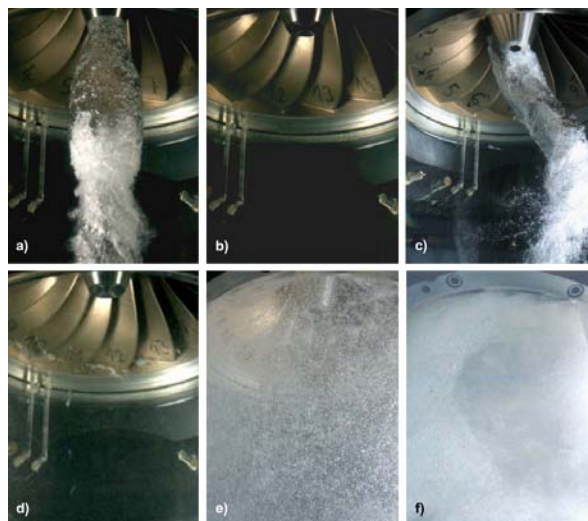
Fig 3: Typical flow patterns of a Francis turbine observed in model tests at the plant sigma: a) high load, b) around BEP, c) part load, d) low part load, e) speed no load-SNL, f) runaway speed [1].

Each above presented cause for crack development on runner blades has typical frequency domain, which can be seen in stress measurement signal, in case that it is influential.

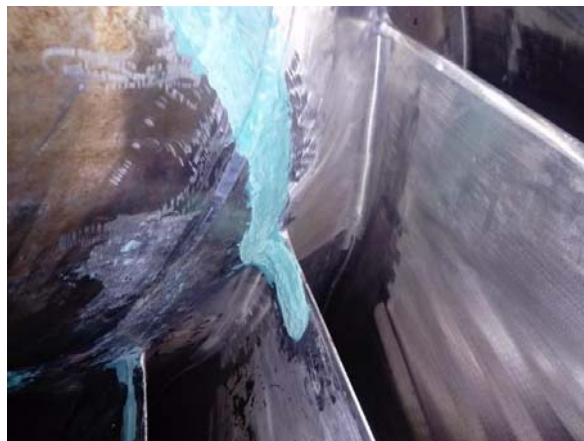
The cables are first led from strain gauge along the runner trailing edge suction side to the crown and inside of the runner cone. At this location cables were protected with rubber hoses to enter the hollow shaft. Exposed part of the cables was additionally protected by a two-component epoxy resin, see 0, with excellent characteristics working under water and pressure and reinforced by one layer of the glass fibre strip.

Fig 5: Detail of the strain gauge and integrated cable protection

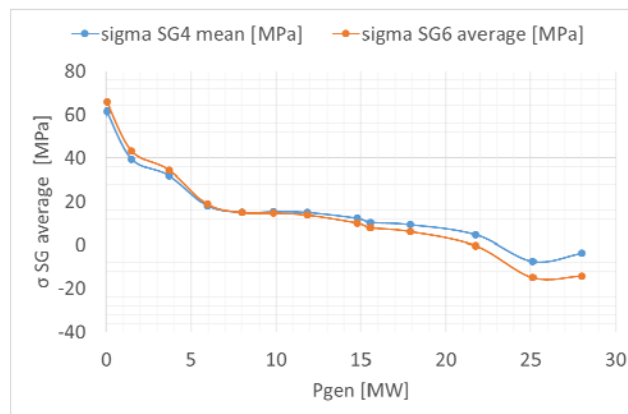
Fig 11: Averaged „static values” of stress at the blade-to-crown trailing edge intersection of blade No. 4 and 6

From the runner durability point of view, idle run is critical. At unit nominal speed “static” stress reached its maximal value – see 0.

Average static stresses and pulsations over whole unit steady state operating range are presented in 0 and 0.

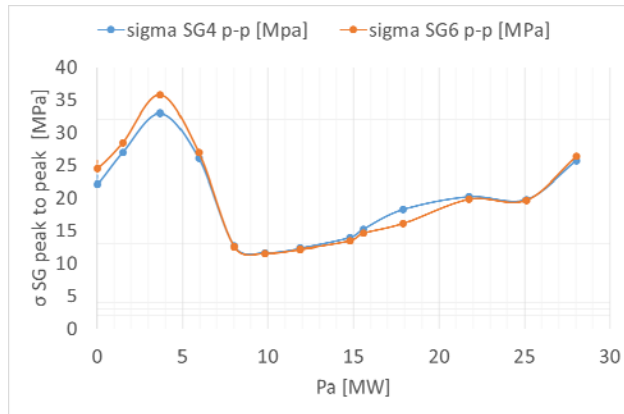
Fig 12: Dynamic stress values at the blade-to-crown trailing intersection of blade No. 4 and 6

Measured “dynamic stress”, expressed as peak-to-peak value, see 0, is increasing from idle run to reach maximal value at part load $P_{gen} = 3.7$ MW. This stress is originated from vortex rope in the draft tube having frequency approximately 1.6 Hz which is 35 % of nominal speed – see 0.

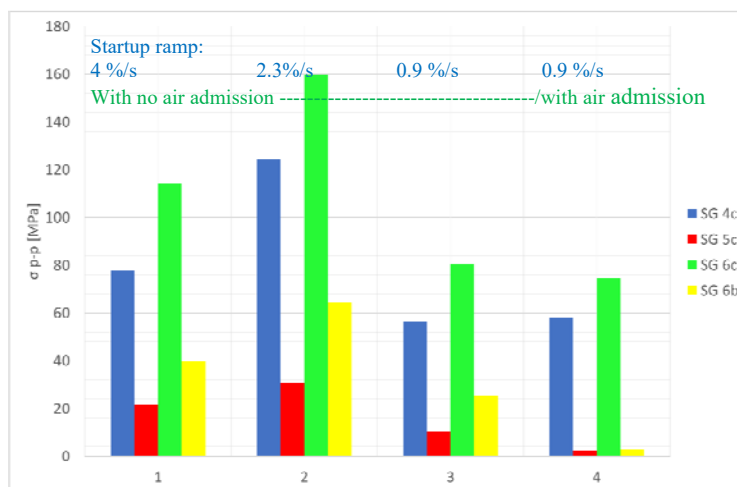
Fig 15: Maximal stress on the suction side of the blades No. 4, 5 and 6 (peak-to-peak)

Testing with different start-up ramps without and with support of air admission was further tested, see 0

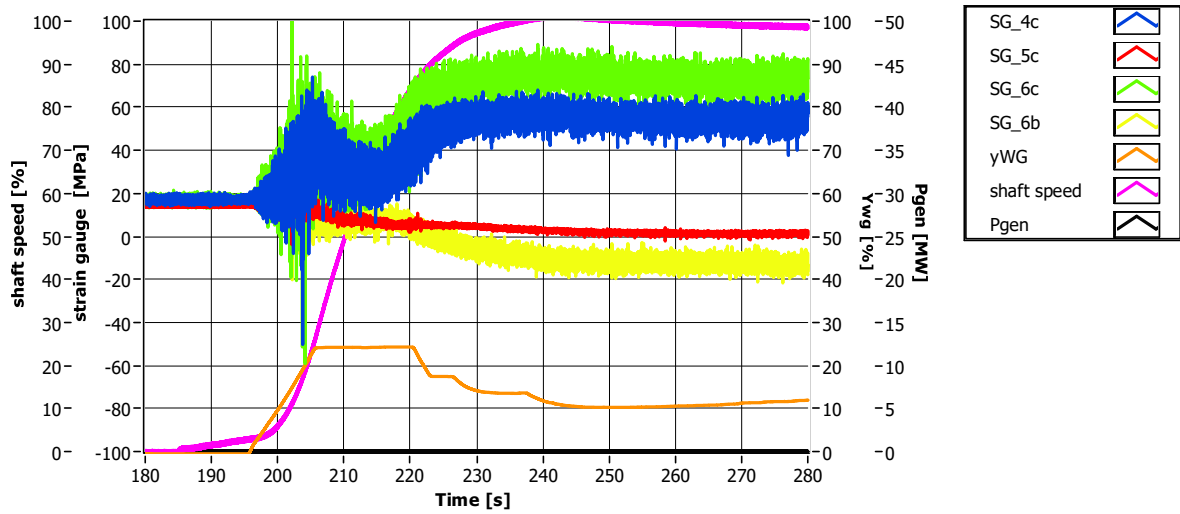
During start-up, the unit is controlled by the hydraulic governor. In the original design, the governor is programmed to open the guide vanes automatically at a set ramp to a value considerably higher than speed-no-load, to provide sufficient torque to overcome initial friction and to accelerate the unit, see 0 and 0.

After speed increase in proximity of nominal speed of rotation, the guide vanes were closed to just slightly higher value than the one required for speed-no-load operation and the control was transferred to the PID section of the governor for fine tuning to speed-no-load and eventual synchronizing.

Fig 16: Measured stresses during initial start-up sequence with no air admission and start-up ramp of 2,3 %/s
